**Flood Control Project Maintenance
Levee Inspections**

Fall 2016 Levee Maintenance Deficiency Summary Report

**Flood Control Project Maintenance
Levee Inspections**
LMA District Cover Sheet
Fall 2016 Levee Inspection Results

Reclamation District No. 0501 Ryer Island

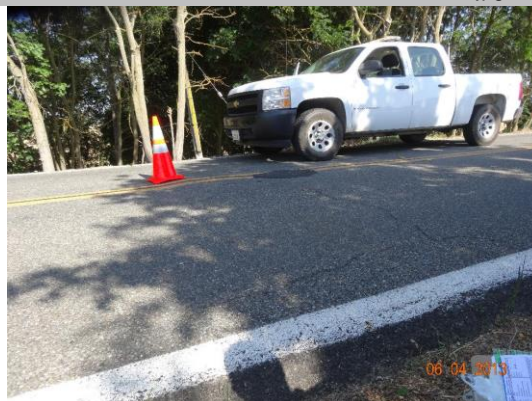
Photo 1 of 2 : UCIP_FA_2016_50063_58923.jpg

UCIP Comments: 8/22/2016 Sacramento County has re-paved road and patch is no longer present. Crossing remains to be Urgent due to the unknown condition of the section of the levee along pipe alignment. Unable to determine if any internal erosion is present along pipe.

According to LMA representative, Stacy Boyd, no additional sink holes have developed since 2013. No sink holes have been noticed since PVC pipe was sleeved through existing steel pipe. Permit authorizing work is not available. Need to identify current owner. Owner will need to coordinate with CVFPB to remove or abandon crossing per Title 23 requirements. (DWR UCIP - omagana)6/04/2013 Damage present on levee crown--unable to confirm if damage due to leak in pipe. Signs of repair work on crown, however, no permit found to document recent damage to levee or repair work. New PVC pipe has been sleeved through the existing 6-inch pipe. Unable to determine if crossing is still in use, if not, crossings needs to be removed according to CVFPB Title 23 requirements. (DWR UCIP - omagana)

View of crown at crossing.

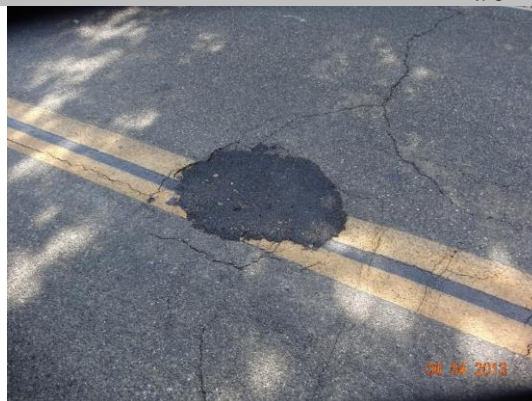
Photo 2 of 2 : UCIP_FA_2016_50063_58922.jpg

FS_ID:50063
DS_ID:21030
EP_NO: 4581
Repair Type: Urgent
Crossing Status: Found
UCIP Comments: 8/22/2016 Sacramento County has re-paved road and patch is no longer present. Crossing remains to be Urgent due to the unknown condition of the section of the levee along pipe alignment. Unable to determine if any internal erosion is present along pipe. According to LMA representative, Stacy Boyd, no additional sink holes have developed since 2013. No sink holes have been noticed since PVC pipe was sleeved through existing steel pipe. Permit authorizing work is not available. Need to identify current owner. Owner will need to coordinate with CVFPB to remove or abandon crossing per Title 23 requirements. (DWR UCIP - omagana)6/04/2013 Damage present on levee crown--unable to confirm if damage due to leak in pipe. Signs of repair work on crown, however, no permit found to document recent damage to levee or repair work. New PVC pipe has been sleeved through the existing 6-inch pipe. Unable to determine if crossing is still in use, if not, crossings needs to be removed according to CVFPB Title 23 requirements. (DWR UCIP - omagana)

Subsidence and patch work repair on crown.

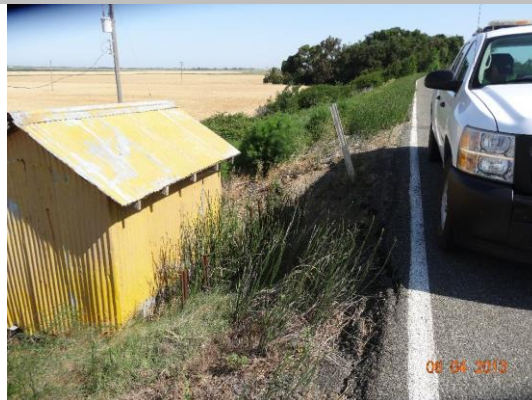
Photo 2 of 2 : UCIP_FA_2016_32524_58927.jpg

Comment Code					
Inspector Comment					
FS_ID:32524					
DS_ID:21031					
EP_NO: N/A					
Repair Type: Non-Urgent					
Crossing Status: Found					
UCIP Comments: Dense vegetation limits the inspector's visibility to identify signs of leaks through the slope. Recommend removing vegetation along pipe alignment for reinspection. Need to contact the owner to clear slope along crossing.					
FIELD_STRUCT_DESC: 20-inch and 2.5-inch pipes through the levee, both 7.8 feet below the crown. Pump in pump house on landward slope. Pipe exposed along waterward slope. (USACE-1959). This entry matches the Drainage or Irrigation Structure referenced in O&M manual (HLM 0.40).					
FS Date: 6/4/2013

Overview of landside. Pump house and power pole visible on landward side.

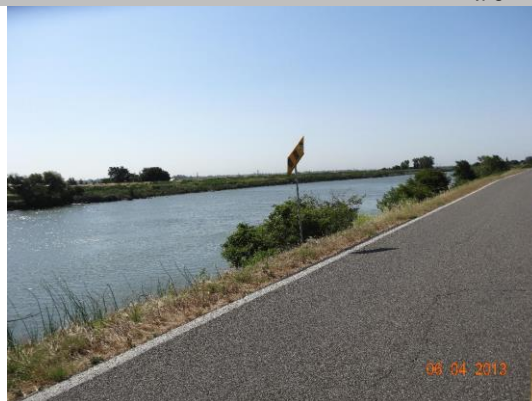
Photo 1 of 2 : UCIP_FA_2016_41409_58931.jpg

LM Start	0.44	Rating **	M	Issue No.	985
LM End	0.44	Issue Type +	En	Location *	LS
Category	Supplemental			GPS Latitude/Longitude	
				Start	End
Item	DWR UCIP Field Study			38.248519 °	38.248519 °
				-121.602972 °	-121.602972 °
DWR ID					
Comment Code					
Inspector Comment					
FS_ID:41409 DS_ID:21032 EP_NO: N/A Repair Type: Non-Urgent Crossing Status: Found UCIP Comments: Need to contact owner and ask for emergency contact information and permit number. 8/21/13 Contacted Gas Control Division under the emergency contact No. 1-877-723-3344. Message has been forward to Brian Habersack at 916-859-4700, email: bhabersack@gasbiz.com. FIELD_STRUCT_DESC: 6-inch Steel Gas line through the levee 60-feet below the crown. Markers on both shoulders (Permit No. 17033, 2014). FS Date: 6/4/2013

Overview of waterside at crossing. Marker on shoulder.

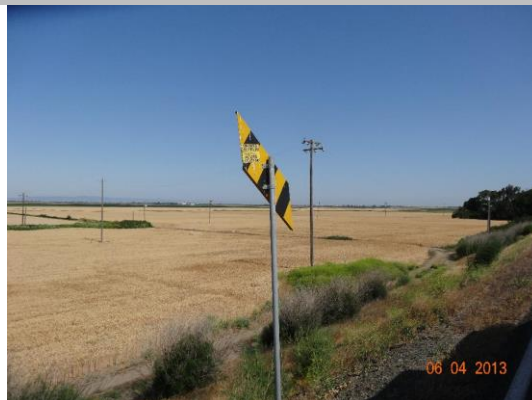
Photo 2 of 2 : UCIP_FA_2016_41409_58930.jpg

Overview of landside at crossing. Marker on shoulder.

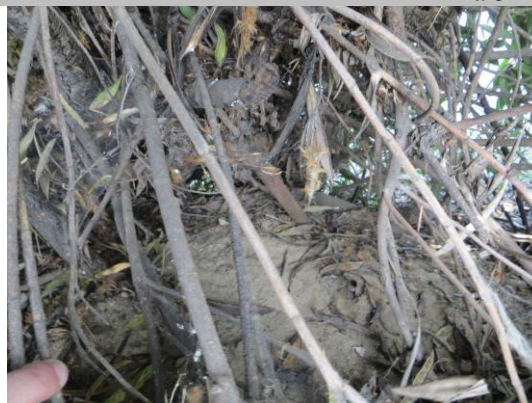
Photo 1 of 2 : UCIP_FA_2016_44643_73842.jpg

LM Start	0.70	Rating **	M	Issue No.	986
LM End	0.70	Issue Type +	En	Location *	LS
Category	Supplemental			GPS Latitude/Longitude	
				Start	End
Item	DWR UCIP Field Study			38.244726 °	38.244726 °
				-121.602900 °	-121.602900 °
DWR ID					
Comment Code					
Inspector Comment					
FS_ID:44643 DS_ID:21089 EP_NO: 2683 Repair Type: Non-Urgent Crossing Status: Indicator Found UCIP Comments: Appears abandoned and if so should be done so properly. FIELD_STRUCT_DESC: *ABANDONED* 2-inch steel water pipe and 1-inch steel electrical conduit through the levee, both 3.0 feet below the crown. Portion of pipe visible under oleanders on LS shoulder may be part of this crossing. No evidence remains on WS slope. (Permit No. 2683-1959, J. Gosner) FS Date: 4/21/2015

Pipes visible under oleander on LS shoulder.

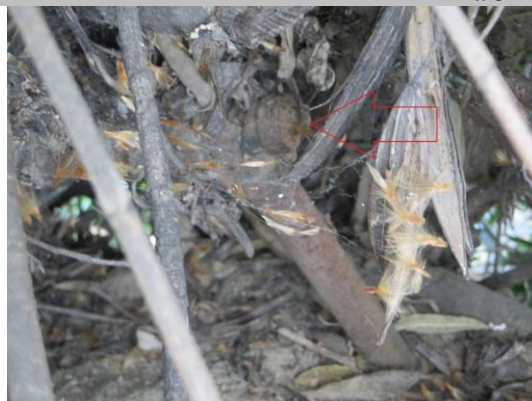
Photo 2 of 2 : UCIP_FA_2016_44643_73841.jpg

LM Start	0.70	Rating **	M	Issue No.	986 (cont)	
LM End	0.70	Issue Type +	En	Location *	LS	
Category	Supplemental			GPS Latitude/Longitude		
				Start		End
Item	DWR UCIP Field Study			38.244726 °	38.244726 °	
				-121.602900 °	-121.602900 °	
DWR ID						
Comment Code						
Inspector Comment						
FS_ID:44643 DS_ID:21089 EP_NO: 2683 Repair Type: Non-Urgent Crossing Status: Indicator Found UCIP Comments: Appears abandoned and if so should be done so properly. FIELD_STRUCT_DESC: *ABANDONED* 2-inch steel water pipe and 1-inch steel electrical conduit through the levee, both 3.0 feet below the crown. Portion of pipe visible under oleanders on LS shoulder may be part of this crossing. No evidence remains on WS slope. (Permit No. 2683-1959, J. Gosner) FS Date: 4/21/2015

Pipes visible under oleander on LS shoulder.

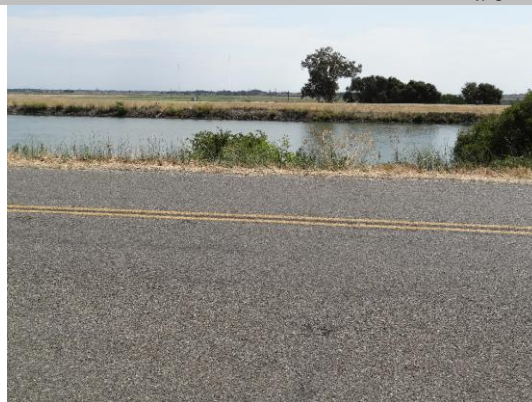
Photo 2 of 2 : UCIP_FA_2016_50020_75647.jpg

FS_ID:50020
DS_ID:21034
EP_NO: N/A
Repair Type: Non-Urgent
Crossing Status: Found
UCIP Comments: 8/22/2016 Crossing has been downgraded from Urgent to Non-Urgent -- no evidence of damage to levee is present. Dense vegetation limits the inspector's visibility to identify signs of pipe failure (leaks) through the slope. Recommend removing vegetation along pipe alignment to conduct proper inspection of structure and appurtenances. Also will need to coordinate with owner to determine if permit was obtained for the modifications made to crossing (PVC pipe sleeved through existing pipe). (DWR UCIP - omagana)4/21/2015 Unauthorized PVC pipe. Annular space not grouted. 14-inch pipe open on both ends. (DWR UCIP - omagana)
FIELD_STRUCT_DESC: 14-inch steel irrigation pipe through the levee, 3.2 feet below the crown. 10-inch polyvinyl chloride (PVC) pipe sleeved through 14-inch with a siphon breaker located on the landside (LS) shoulder. [Additional Reference(s): DWR Levee Log, 1980 and 2005. USACE Sacramento O&M Manual Unit No. 105, April 1959, (HLM 1.0)].

View of levee crown looking at waterside.

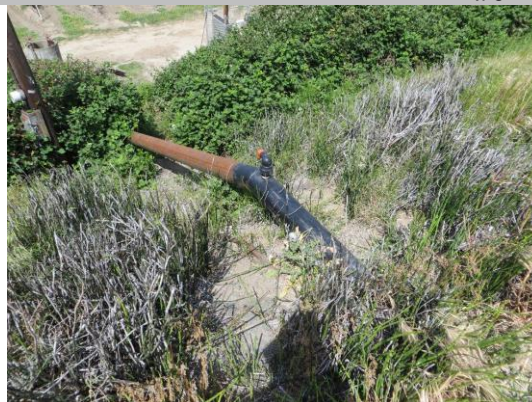
Photo 2 of 2 : UCIP_FA_2016_47516_73856.jpg

FS_ID:47516
DS_ID:21086
EP_NO: 13233
Repair Type: Non-Urgent
Crossing Status: Found
UCIP Comments: Annular space between pipes not grouted. FPIIB Inspector Herman Phillips will contact owner regarding lack of permit for sand filters. Steel plate partially covers openings between pipes.
FIELD_STRUCT_DESC: 14-inch steel pipe through the levee, 2.5-feet below the crown. Cutoff wall around pipe at center of levee. Pump and check valve in pump house on waterward slope. Service pole on landward slope. (Permit No. 13233-1982) 8-inch steel irrigation pipe sleeved through 14-inch (under Permit No. 11813-1, 2013). A 1.5 and a 2.5-inch electrical conduit at same location. Siphon breaker on both shoulders.
FS Date: 4/21/2015

8-inch steel pipe with vent/siphon breaker on LS shoulder. Pipe sleeved through 14-inch steel pipe. Electrical conduit visible next to pipe.

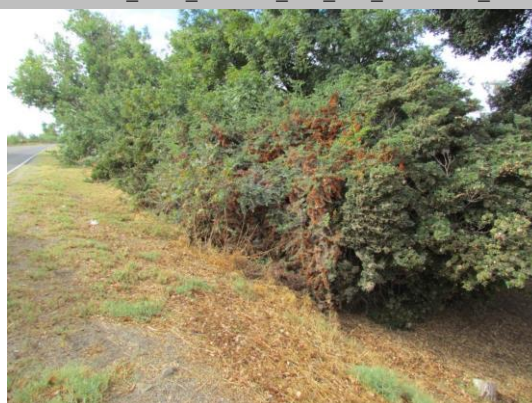
Photo 1 of 1 : FA_2016_RD0501_169_116_20161018_00010.jpg

Looking downstream at the woody tree growth on the landward levee slope. No new photo taken.

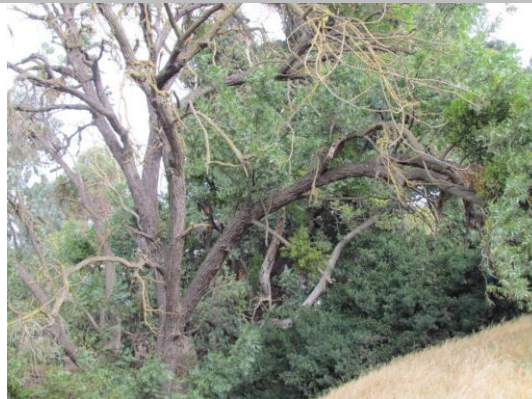
Photo 1 of 1 : FA_2016_RD0501_169_6_20161018_00005.jpg

LM Start	2.32	Rating **	U	Issue No.	6
LM End	2.32	Issue Type +	Ma	Location *	LS
Category	Earthen Levee			GPS Latitude/Longitude	
				Start	End
Item	Trim / Thin Trees			38.221455°	38.221455°
				-121.603508°	-121.603508°
DWR ID	DWR_RD0501_01_f_2015_6				
Comment Code					
T1 : Trim trees to at least five feet above ground level.					
Inspector Comment					
This tree at this location is dead and poses a threat that could cause injury to persons or levee damage. No new photo taken.

This photo shows an old dead cotton wood tree at the landside levee toe.

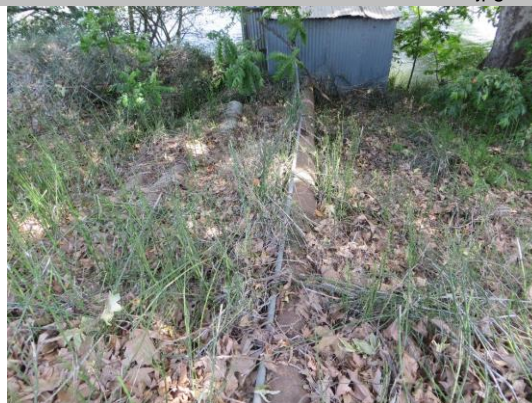
Photo 2 of 2 : UCIP_FA_2016_44683_73881.jpg

LM Start	2.34	Rating **	M	Issue No.	987
LM End	2.34	Issue Type +	En	Location *	LS
Category	Supplemental			GPS Latitude/Longitude	
				Start	End
Item	DWR UCIP Field Study			38.221277 °	38.221277 °
				-121.603505 °	-121.603505 °
DWR ID					
Comment Code					
Inspector Comment					
FS_ID:44683 DS_ID:21021 EP_NO: N/A Repair Type: Non-Urgent Crossing Status: Found UCIP Comments: Appears abandoned and if so should be done so properly. Discarded pipe on WS slope should be removed. FIELD_STRUCT_DESC: 10-inch steel irrigation pipe through the levee, 2.5-feet below the crown. Pump and gate valve in pump house on waterward slope. a 4'X4' concrete distribution box, power pole, and meter on LS toe (USACE-1959). This entry matches the Drainage or Irrigation Structure referenced in O&M manual (HLM 2.50). FS Date: 4/21/2015

Pipe and pump house on WS slope.

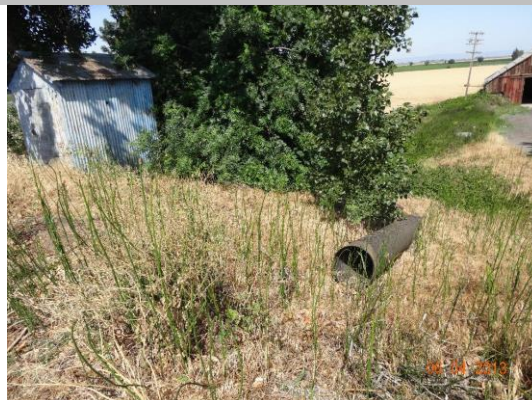
Photo 2 of 2 : UCIP_FA_2016_32526_58935.jpg

UCIP Comments: Dense vegetation limits the inspector's visibility to identify signs of pipe failure (leaks) through the levee slopes.

FIELD_STRUCT_DESC: 16-inch drainpipe through the levee, 3.6 feet below the crown. Cutoff walls around pipe at center of levee. Siphon breaker on apex of pipe at landward shoulder. Pump house on landward shoulder. Pipe discharges into 48-inch pipe with screw gate on landward side. (Permit No. 2742-1959). Repairs made to pipe and a portion replaced, from landward shoulder to discharge end on waterward side, under Permit No. 15380 (1999). Rock revetment placed on waterward slope. Revegetation in progress on waterside.

Pump house on landward slope. An abandoned pipe section on landward slope.

Recommend removing vegetation along pipe alignment to conduct proper inspection of structure and appurtenances. Additional notes: pump was running during inspection, 16-inch pipe debris section located on landward side, view of standpipe and support structure on waterward side does not match structure description--need to determine if crossing has been altered.

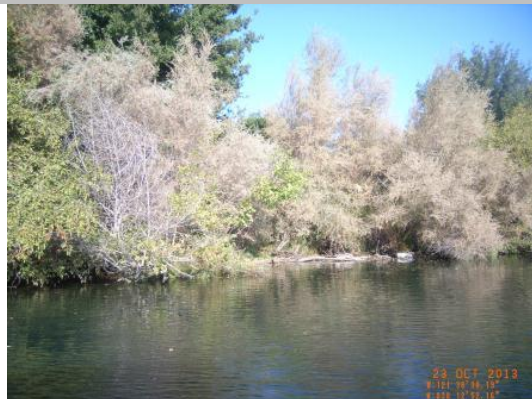
Photo 1 of 1 : FA_2016_RD0501_169_3_20161018_00003.jpg

LM Start	2.85	Rating **	M	Issue No.	3
LM End	2.91	Issue Type +	Ma	Location *	WS
Category	Supplemental			GPS Latitude/Longitude	
				Start	End
Item	2015 USACE Erosion Survey, DRAFT			38.214838 °	38.214075 °
				-121.608129 °	-121.608750 °
DWR ID	DWR_RD0501_01_f_2016_3				
Comment Code					
Inspector Comment					
2009 - Rock is starting to unravel, probably from a tree pop-out, hard toe. 2015: No observed changes. [2015 Site ID: STM_18-9_R]

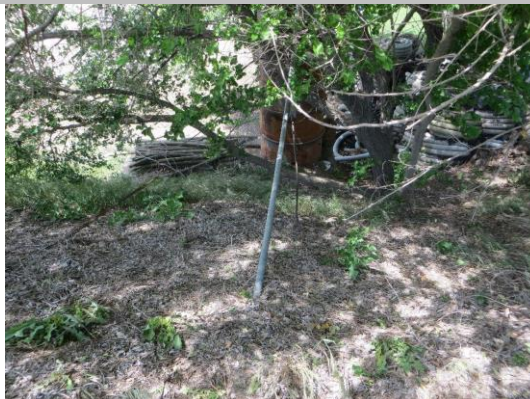
Photo 1 of 2 : UCIP_FA_2016_44688_73891.jpg

LM Start	2.97	Rating **	M	Issue No.	988
LM End	2.97	Issue Type +	En	Location *	LS
Category	Supplemental			GPS Latitude/Longitude	
				Start	End
Item	DWR UCIP Field Study			38.213439 °	38.213439 °
				-121.609583 °	-121.609583 °
DWR ID					
Comment Code					
Inspector Comment					
FS_ID:44688					
DS_ID:21025					
EP_NO: N/A					
Repair Type: Non-Urgent					
Crossing Status: Found					
UCIP Comments: Pipe appears abandoned and if so should be done so properly.					
FIELD_STRUCT_DESC: 2-inch galvanized iron irrigation pipe through the levee, 3.2 feet below the crown. 6-foot diameter steel standpipe at LS toe. Pipe may run parallel to levee crown to cross levee at site of 14-inch HLM: 2.98					
FS Date: 4/21/2015

Pipe visible at LS shoulder. Pipe connects to top of steel standpipe at LS toe.

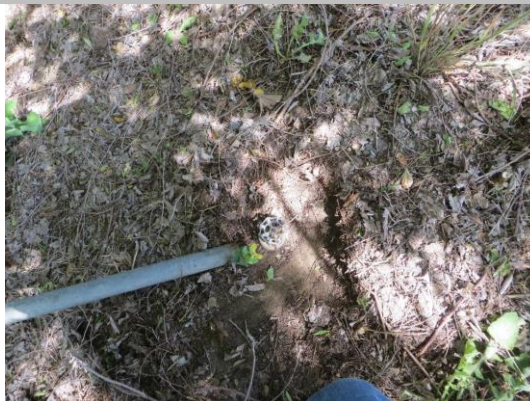
Photo 2 of 2 : UCIP_FA_2016_44688_73890.jpg

Shutoff valve at LS shoulder.

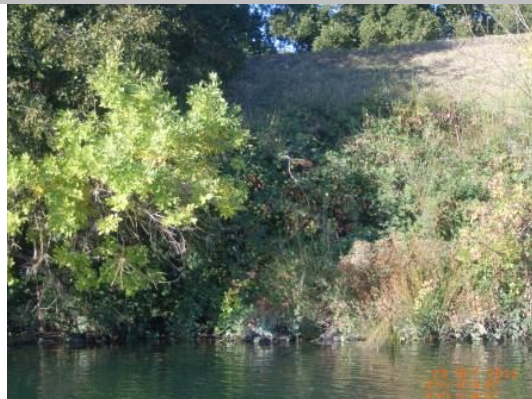
Photo 1 of 1 : FA_2016_RD0501_169_2_20161018_00002.jpg

LM Start	3.04	Rating **	M	Issue No.	2
LM End	3.11	Issue Type +	Ma	Location *	WS
Category	Supplemental			GPS Latitude/Longitude	
				Start	End
Item	2015 USACE Erosion Survey, DRAFT			38.212573 °	38.211596 °
				-121.609760 °	-121.609928 °
DWR ID	DWR_RD0501_01_f_2016_2				
Comment Code					
Inspector Comment					
2000 - Slow erosion of lower and mid-slope with rock bench at the low water line. 2015: No observed changes. [2015 Site ID: STM_18-8_R]

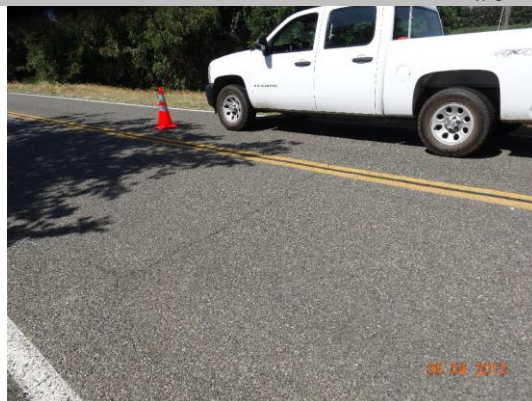
Photo 1 of 2 : UCIP_FA_2016_50022_58942.jpg

View of levee crown at crossing. Single line crack on levee crown.

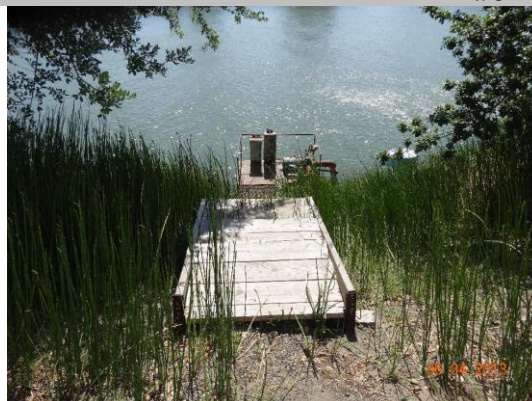
Photo 2 of 2 : UCIP_FA_2016_50022_58940.jpg

Station details--gate valve, air vent, and other appurtenances.

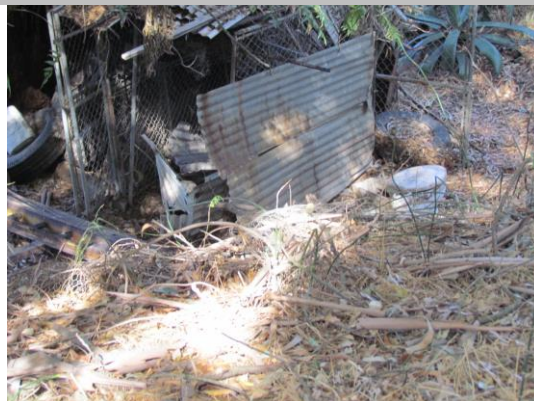
Photo 2 of 3 : FA_2016_RD0501_169_63_20161021_00062.jpg

RD 501 Levee mile 3.24 landside toe.

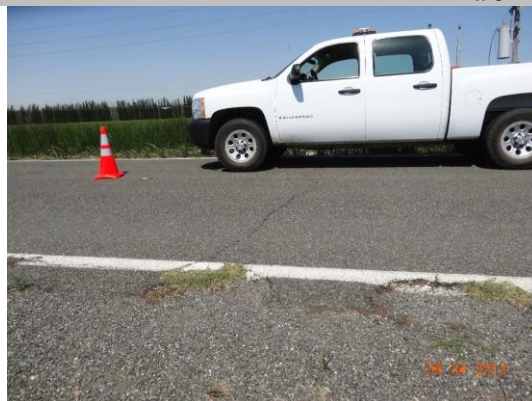
Photo 1 of 2 : UCIP_FA_2016_32529_58954.jpg

Single line crack on crown.

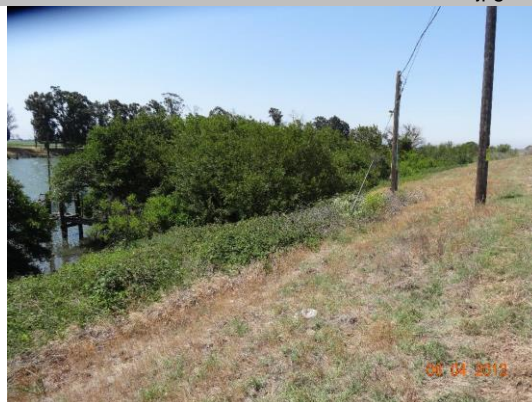
Photo 2 of 2 : UCIP_FA_2016_19644_33331.jpg

Overview of waterward side--pump station, platform, & power pole.

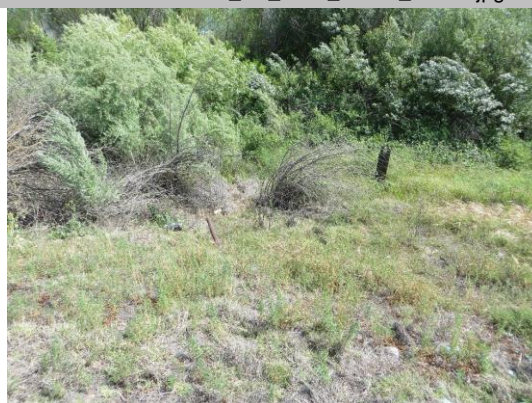
Photo 2 of 2 : UCIP_FA_2016_50024_73900.jpg

2.5-inch conduit visible on WS slope.

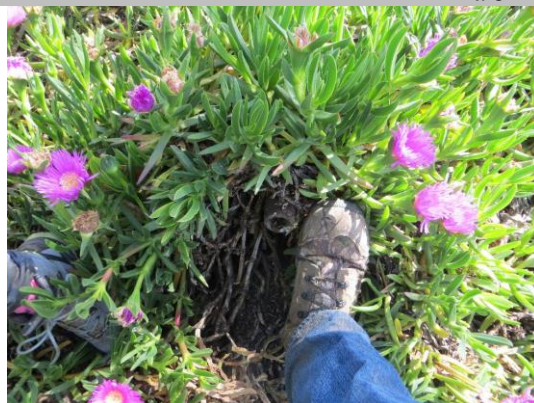
Photo 1 of 2 : UCIP_FA_2016_44720_73904.jpg

Pipe visible on LS slope. Succulants mound up over pipe.

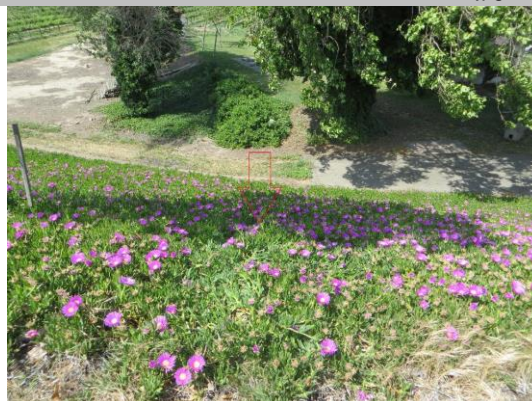
Photo 2 of 2 : UCIP_FA_2016_44720_73903.jpg

Mound at pipe visible on LS slope.

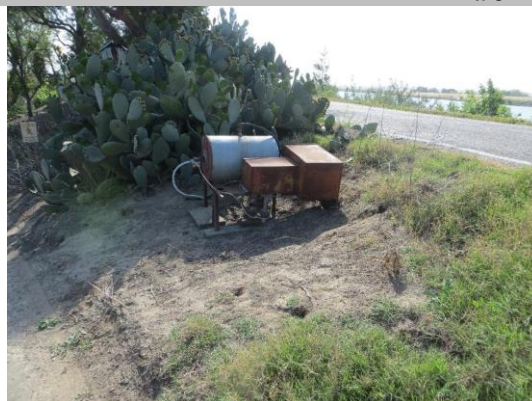
Photo 1 of 2 : UCIP_FA_2016_44726_73922.jpg

Siphon pump on LS shoulder. No connection at this time.

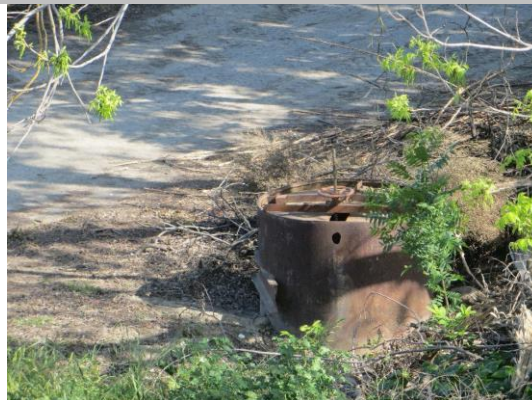
Photo 2 of 2 : UCIP_FA_2016_44726_73921.jpg

Steel standpipe and gatevalve on LS toe.

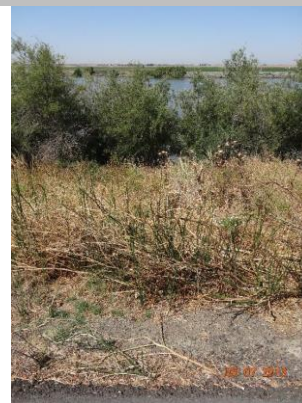
Photo 1 of 2 : UCIP_FA_2016_19657_33396.jpg

Dense vegetation along the crown hinge point and beginning section of waterward slope.

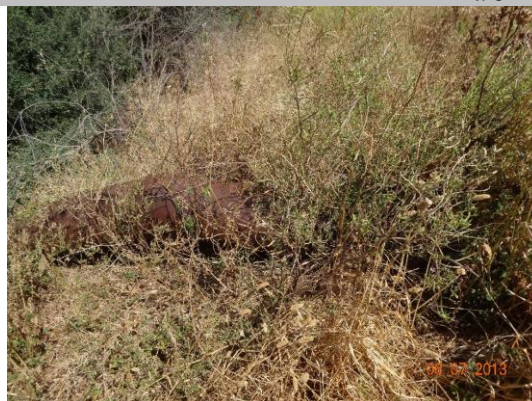
Photo 2 of 2 : UCIP_FA_2016_19657_33400.jpg

Dense vegetation along the upper portion of the waterward slope prevents proper inspection of crossing.

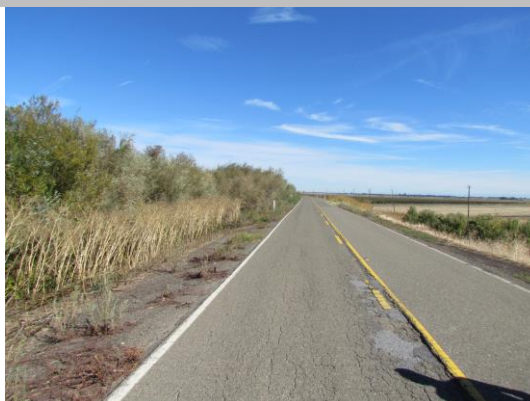
Photo 1 of 1 : FA_2016_RD0501_171_35_20161021_00069.jpg

RD 501 Unit 3 levee mile 0.51 downstream to 0.61 waterside shoulder and slope.

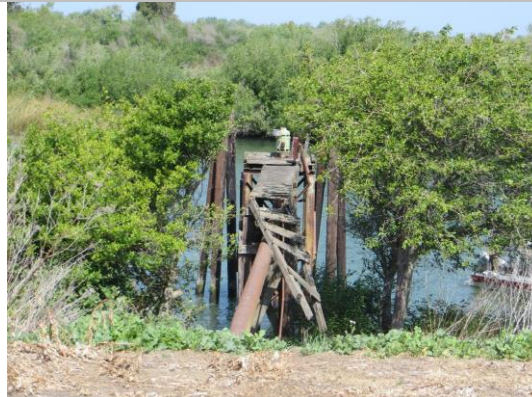
Photo 2 of 2 : UCIP_FA_2016_44728_73923.jpg

Pump on wooden pier off WS toe.

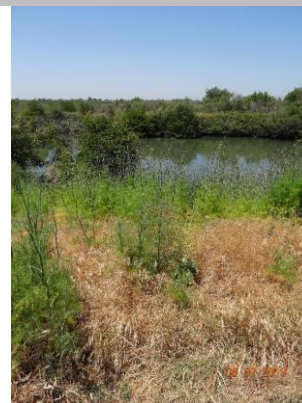
Photo 1 of 2 : UCIP_FA_2016_43503_33410.jpg

Overview of waterward side. Pipe is completely obstructed by dense vegetation.

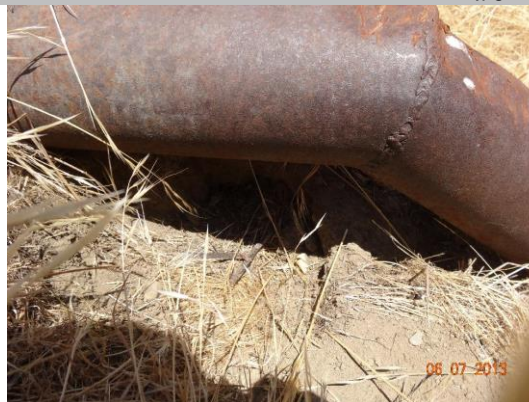
Photo 2 of 2 : UCIP_FA_2016_46768_30381.jpg

Burrow activity visible underneath pipe alignment.

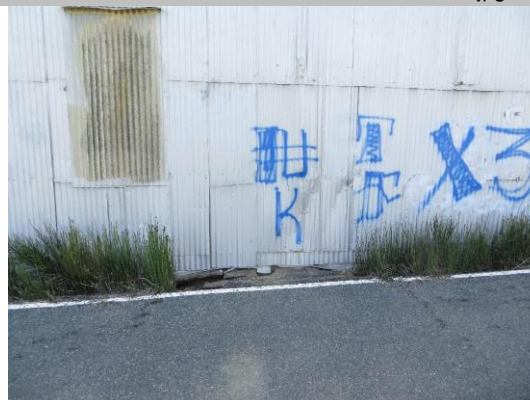
Photo 1 of 2 : UCIP_FA_2016_50023_73942.jpg

Building on LS shoulder prevents access to LS of levee.

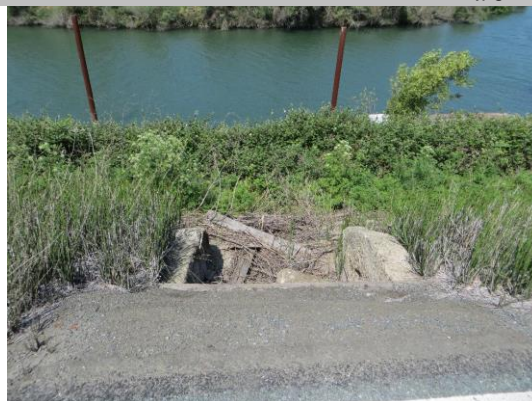
Photo 2 of 2 : UCIP_FA_2016_50023_73941.jpg

Concrete tunnel and wingwalls visible on WS slope.

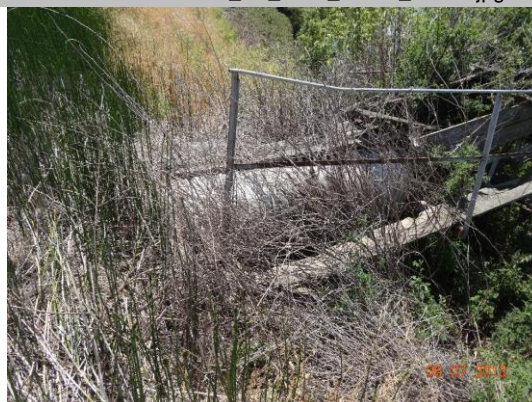
Photo 1 of 2 : UCIP_FA_2016_19662_33420.jpg

View of waterward side. Pipe visible through dense vegetation.

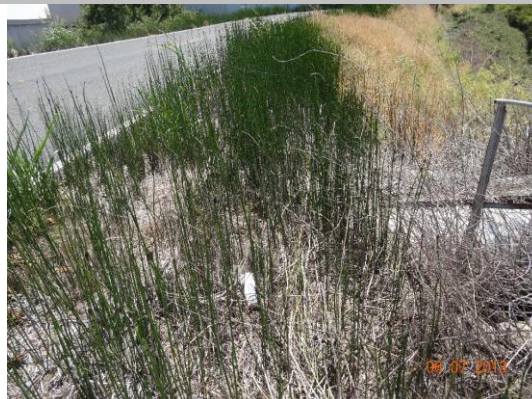
Photo 2 of 2 : UCIP_FA_2016_19662_33418.jpg

Dense vegetation along the pipe alignment and throughout waterward slope.

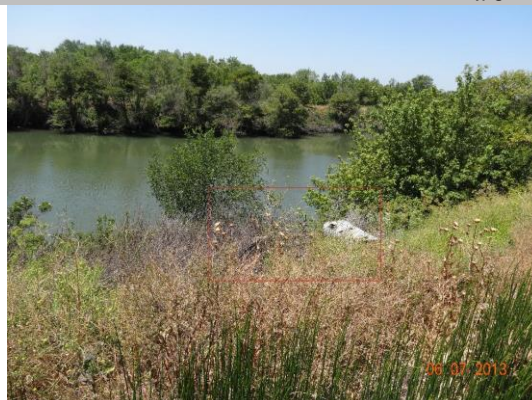
Photo 1 of 2 : UCIP_FA_2016_43524_33425.jpg

View of waterward side. Dense vegetation limits inspections. Signs of structure visible highlighted by red box.

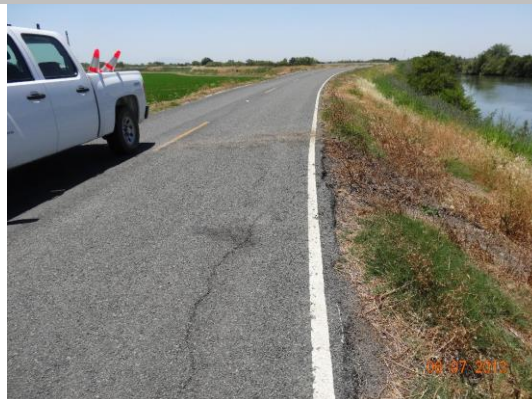
Photo 1 of 2 : UCIP_FA_2016_44876_33427.jpg

Line cracks along crown near crown hinge point on waterward side.

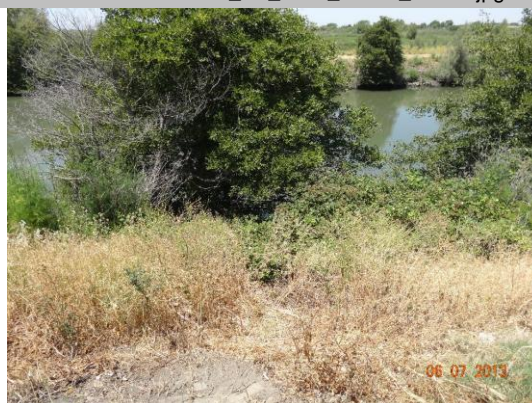
Photo 2 of 2 : UCIP_FA_2016_44876_33428.jpg

View of waterward slope. Dense vegetation along slope.

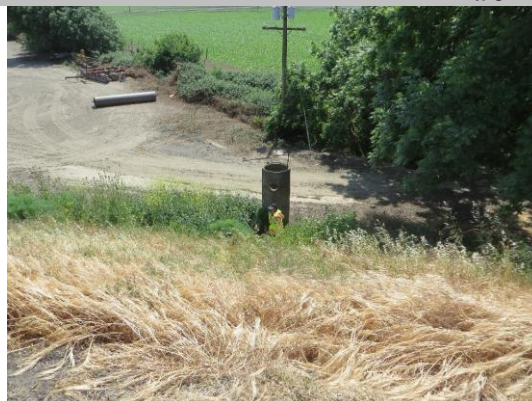
Photo 1 of 2 : UCIP_FA_2016_44746_73944.jpg

34-inch diameter concrete standpipe at LS toe.

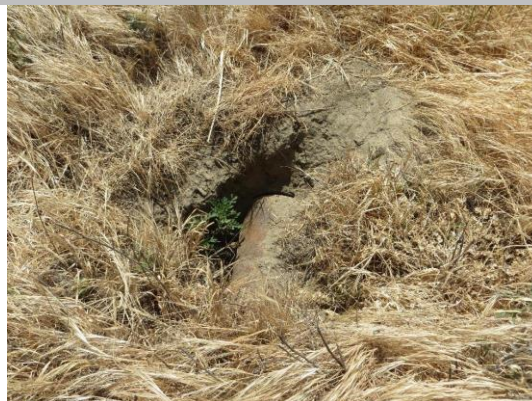
Photo 2 of 2 : UCIP_FA_2016_44877_73945.jpg

Cut in buried pipe on LS shoulder.

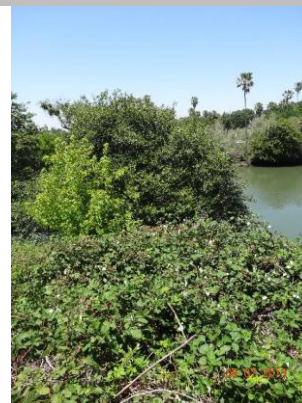
Photo 2 of 2 : UCIP_FA_2016_19666_33434.jpg

Structure visible through the dense vegetation. Limited access unable to inspect.

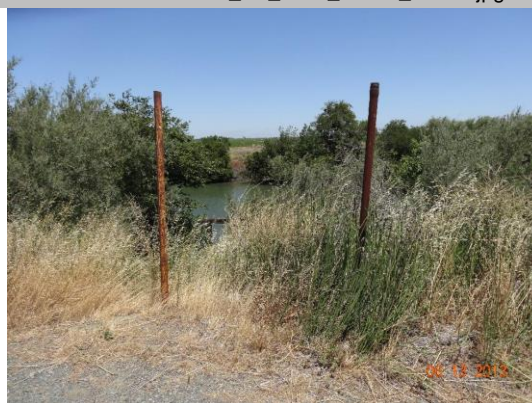
Photo 2 of 2 : UCIP_FA_2016_19668_33443.jpg

View of waterward side. Metal posts near the levee crown.

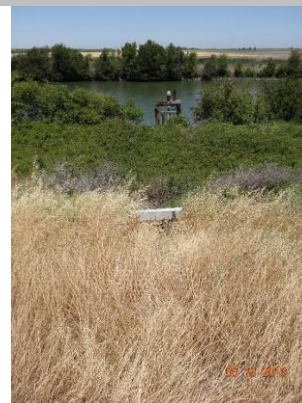
Photo 1 of 2 : UCIP_FA_2016_32544_59034.jpg

View of waterward side. Support piles, conduit line, and pump visible on waterward side. Dense vegetation covers waterward slope.

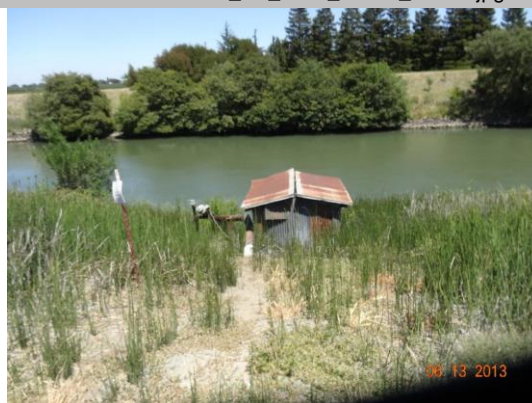
Photo 2 of 2 : UCIP_FA_2016_32547_59051.jpg

Overview of waterward side--2 crossings located within 5 feet.

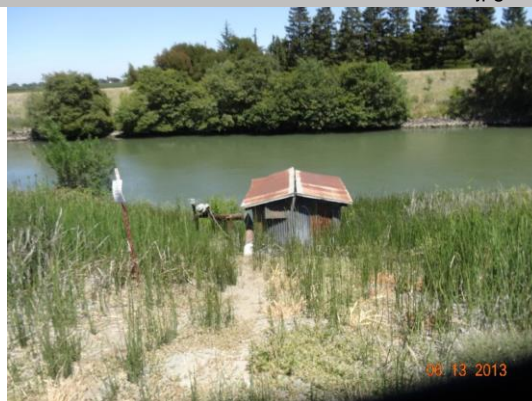
Photo 2 of 2 : UCIP_FA_2016_32548_59058.jpg

Overview of waterward side. Two crossings, 10 inch and 8 inch pipelines, less than 5 feet apart.

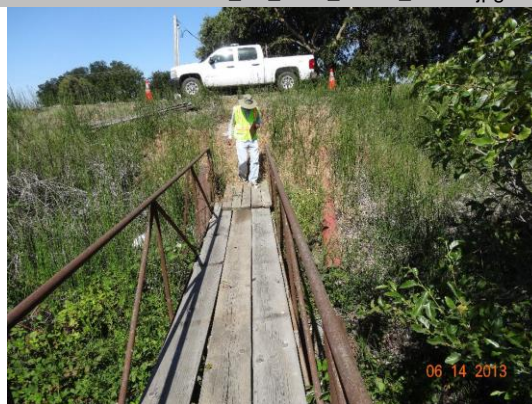
Photo 2 of 2 : UCIP_FA_2016_32551_59072.jpg

Abandoned pipe to the right of walkway.

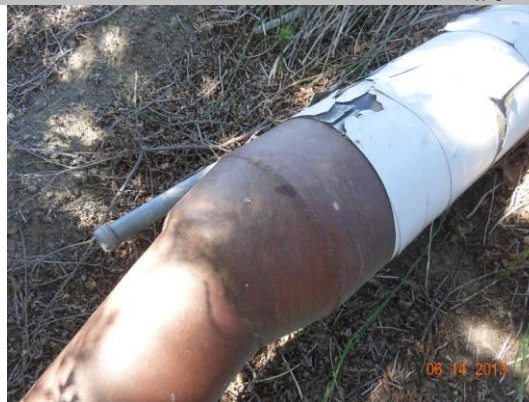
Photo 2 of 2 : UCIP_FA_2016_44471_33495.jpg

Pipe section reduced at the waterward side daylight.

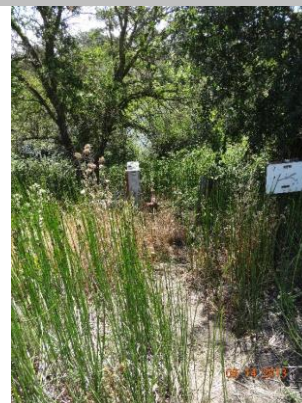
Photo 2 of 2 : UCIP_FA_2016_32863_59484.jpg

View of waterward side with dense vegetation along slope.
